WISCONSIN HIGHWAY RESEARCH PROGRAM

PROJECT NO. 0092-01-06

**REHABILITATION TECHNIQUES FOR
CONCRETE BRIDGES**

DRAFT FINAL REPORT

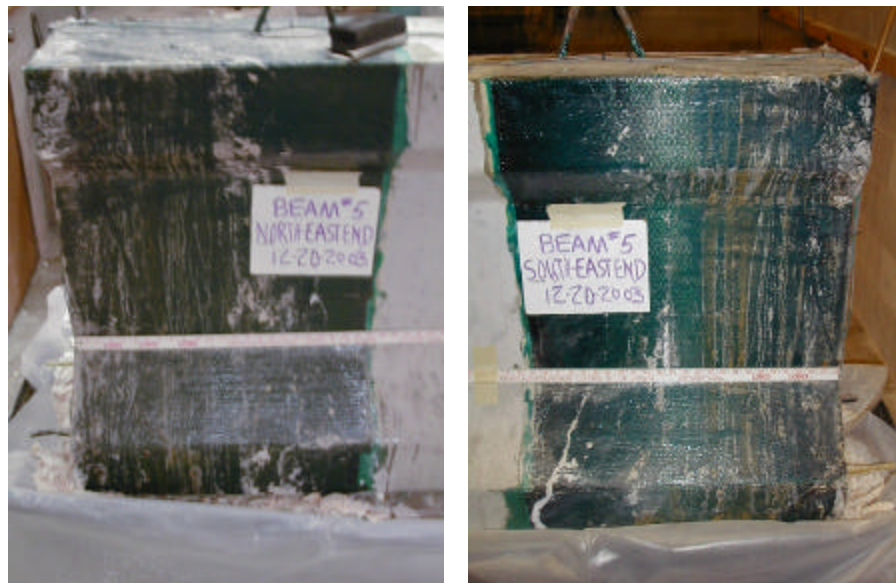
Figure 93. Beam End 4B: Northeast (untreated, post-FRP) (left), Southeast (right) (18 months)

No spalling or major cracking was observed on either of the beam-ends at the end of 18 months of exposure.

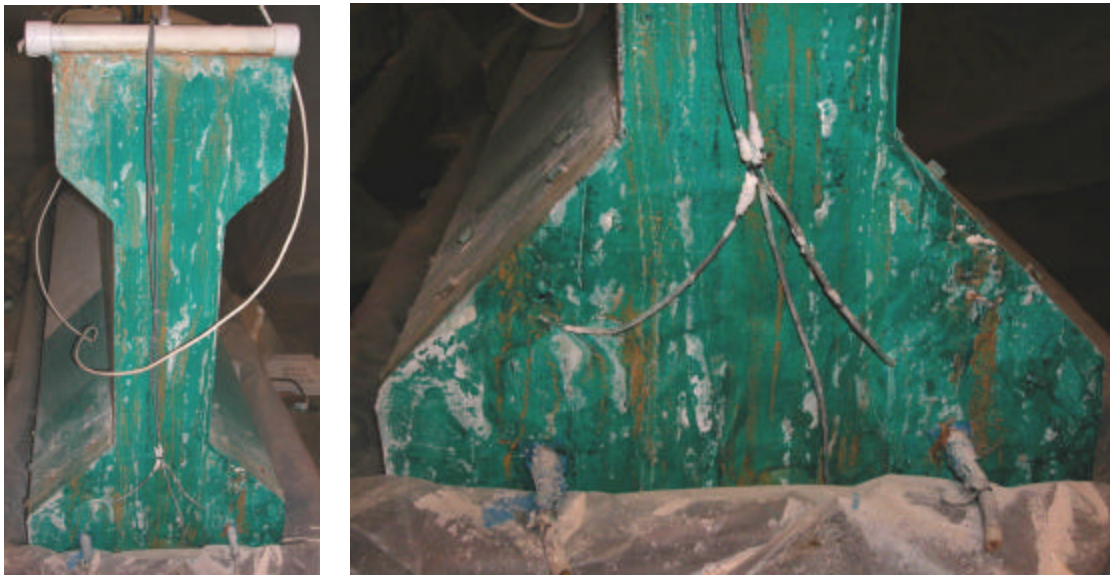
Figure 94. Beam End 5A: West End (pre-polymer)(After 6 months)

No major spalling or cracking was observed at the end of 6 months of exposure.

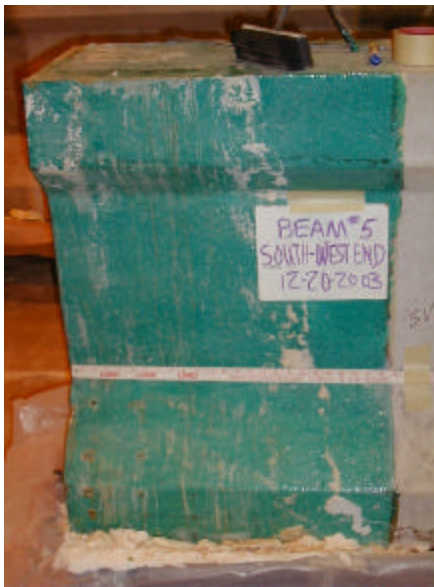
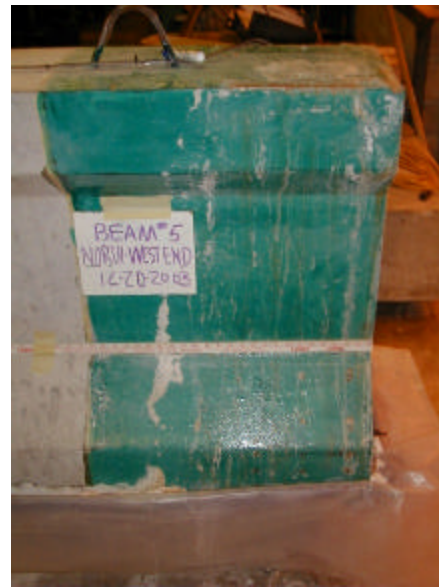
Figure 99. Beam End 5A: Southwest Face (left), Northwest Face (right) (18 months)

After 18 months of exposure, no spalling or major cracking was observed on either of the beam-ends. Crack maps for all beams are shown in section 5.3.

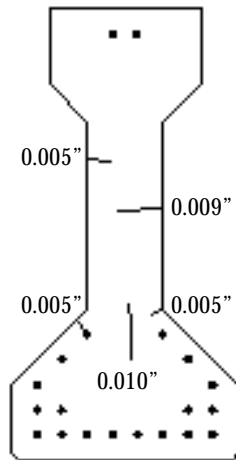
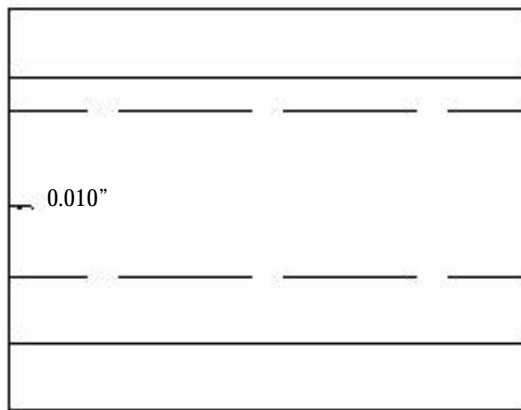
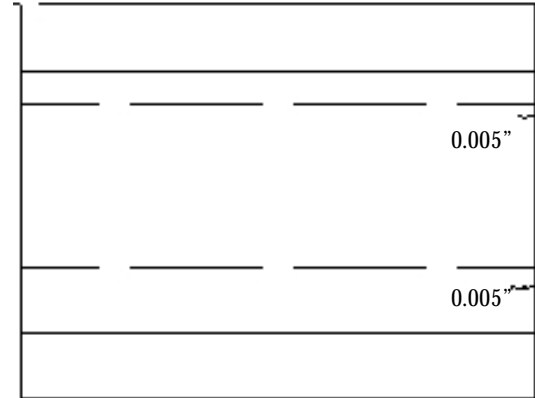
Figure 101. Beam End 1A: West End (top), Southwest (left), Northwest (right) (6 months)

Crack maps for all beam-ends were obtained at the completion of the first 6 months of exposure and at the conclusion of all tests (18 months). Figures 101 and 102 illustrate the crack maps for the west (1A, pre-coated) and east (1B, untreated, post-coated) ends. The crack widths on the west face varied from 0.005 to 0.010 inches. The northwest face crack width was 0.005 inches and the southwest face crack width was 0.010 inches. The crack width on the east face was measured to be equal to 0.005 inches. No cracks were observed on the northeast and southeast faces.

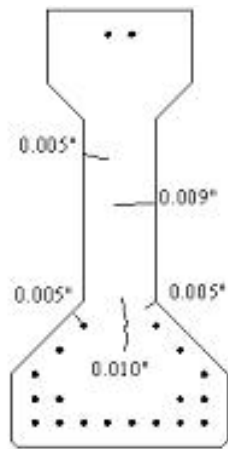
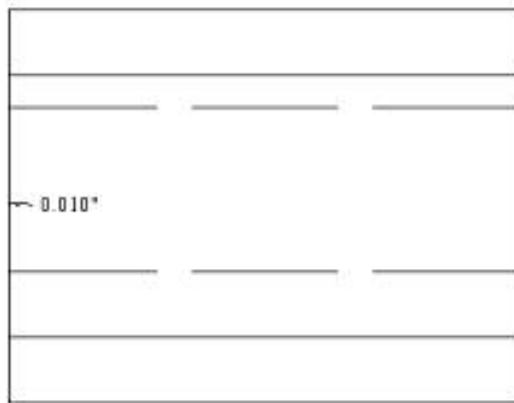
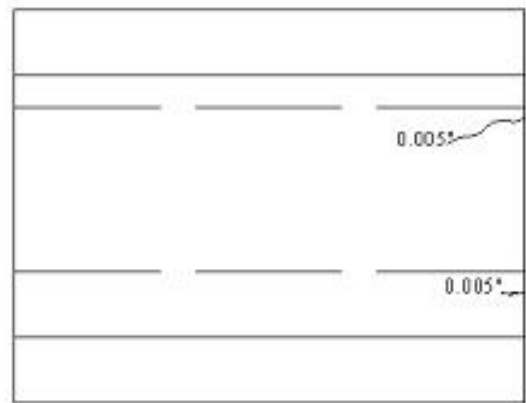
Figure 103. Beam End 1A: West End (top), Southwest (left), Northwest (right) (18 months)

Figures 103 and 104 show crack maps for the 1A and 1B ends at the conclusion of testing (18 month). There is only a slight progression of cracking on the northwest side of 1A from 6 months of exposure to 18 months. However, the 1B end did develop extensive new cracks at the end of the 18-month exposure period. This is expected as 1B was subjected to 6 months of unprotected exposure to saltwater before application of epoxy coating.

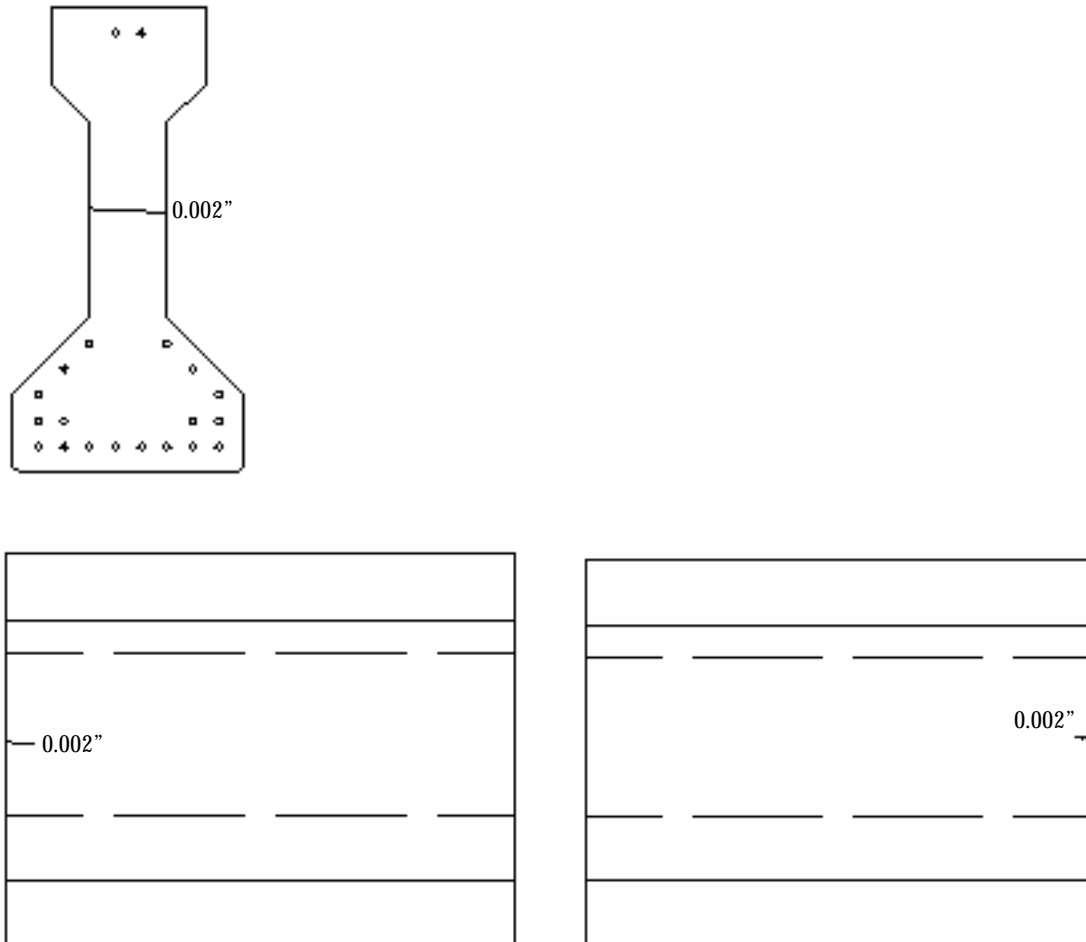
Figure 105. Beam End 2A: West End (top), Southwest (left), Northwest (right)(6 months)

Crack maps for both beam-ends were obtained at the completion of the first 6 months of exposure and at the conclusion of all tests. Figures 105 and 106 illustrate the crack maps for the west end 2A (untreated) and east end 2B (untreated, patched) at the end of 6 months of exposure. The crack widths on the west face varied from 0.003 to 0.005 inches. The northwest face crack width was 0.002 inches and the southwest face crack width was 0.002 inches. The crack widths on the east face ranged between 0.002 and 0.003 inches. The southeast crack widths were between 0.002 and 0.003 inches. No cracks were observed on the

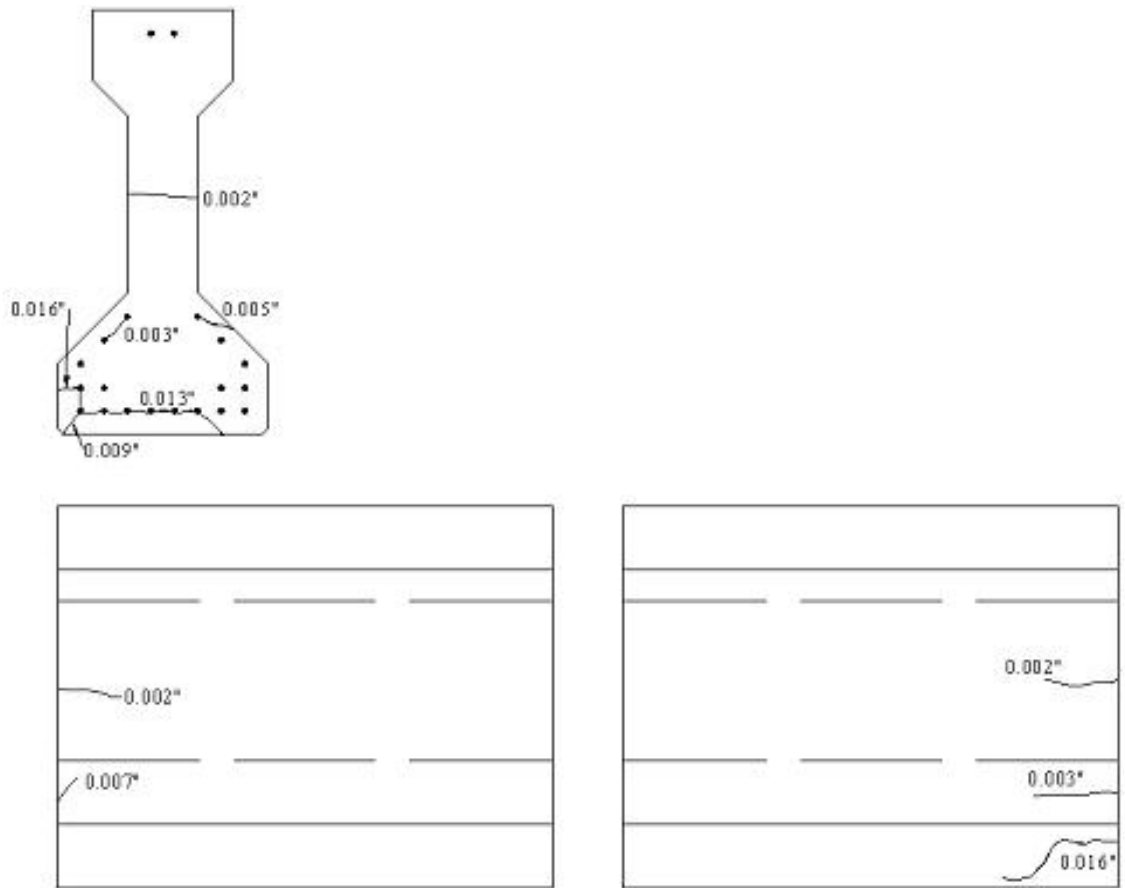
Figure 107. Beam End 2A: West End (top), Southwest (left), Northwest (right)(18 months)

It is clear that cracking grew between 6 and 18 months, especially for beam end 2B (patched end). The cracks between strands indicate the onset of spalling. The crack sizes are also large.

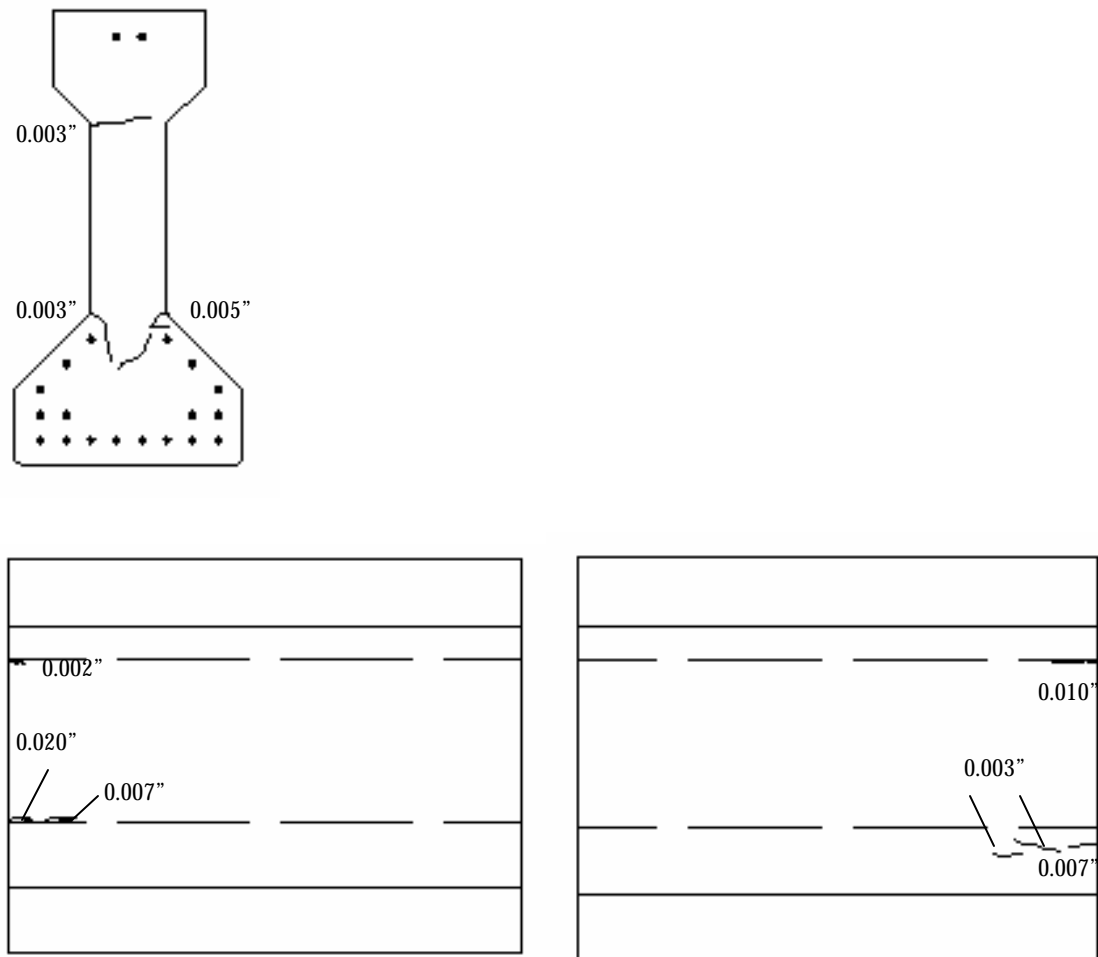
Figure 109. Beam End 3A: West End (top), Southwest (left), Northwest (right) (6 months)

Crack maps for both beam-ends were obtained at the completion of the first 6 months of exposure and the conclusion of all tests. Figures 109 and 110 illustrate the crack maps for the west end 3A (pre-sealed) and east end 3B (untreated, post-sealed). After 6 months, the crack widths on the west face varied from 0.003 to 0.005 inches. The northwest face crack widths ranged between 0.003 and 0.010 inches and the southwest face crack widths were between

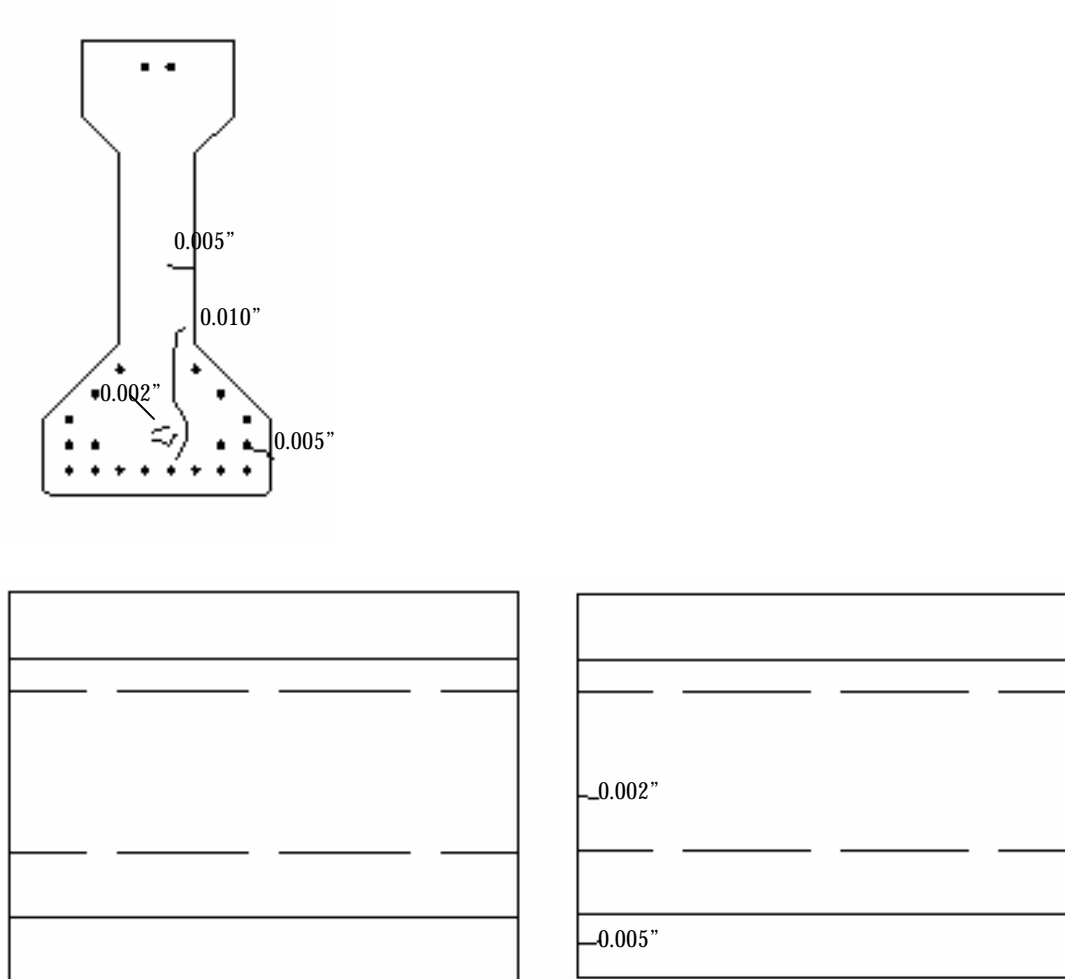
Figure 110. Beam End 3B: East End (top), Southeast (left), Northeast (right) (6 months)

0.002 and 0.020 inches. The crack widths on the east face ranged between 0.002 and 0.010 inches. The northeast crack widths were between 0.002 and 0.005 inches. No cracks were observed on the southeast face after 6 months of exposure. Figure 111 and 112 show crack maps after 18 months of exposure for 3A and 3B, respectively. Again, crack growth was clearly evident in both beam-ends.

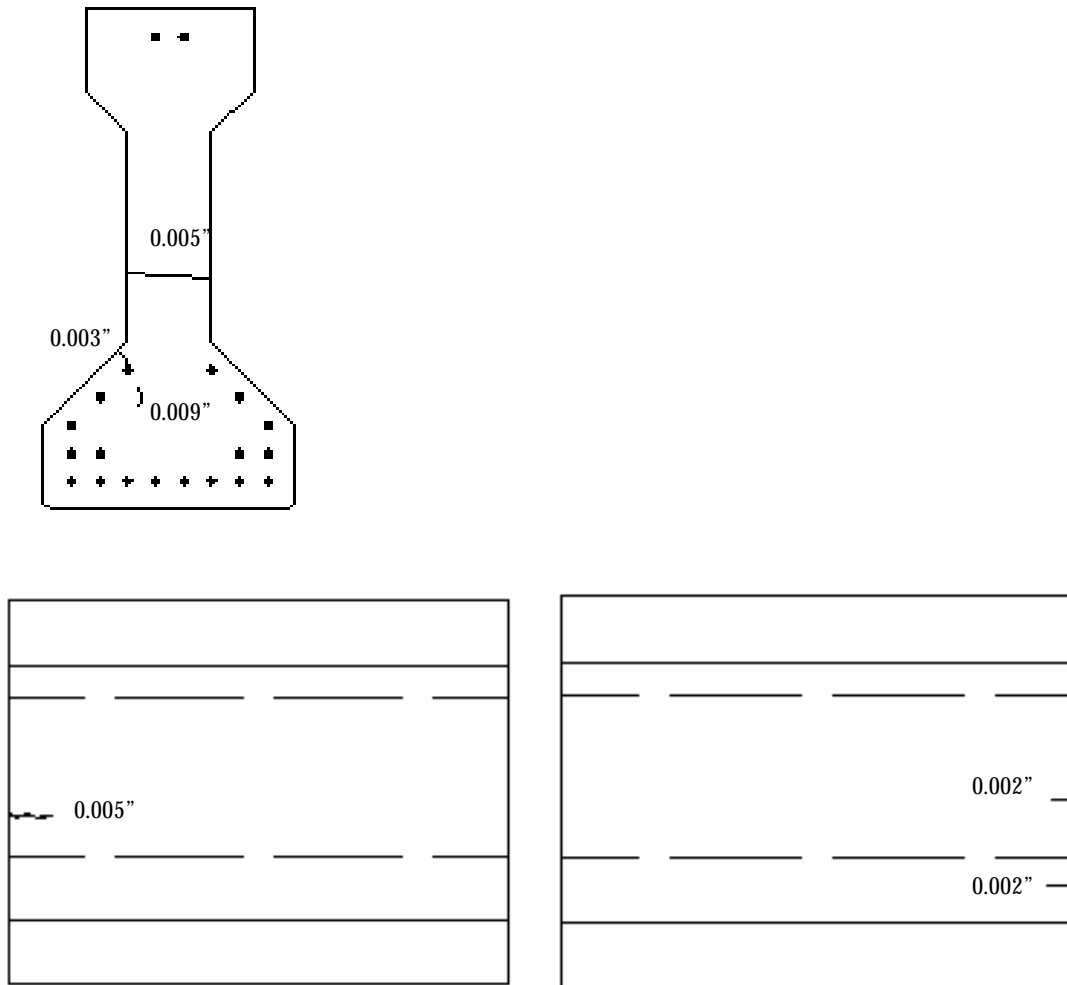
Figure 113. Beam End 4A: West (top), Southwest (left), Northwest (right) (6 months)

Crack maps for both beam-ends were obtained at the completion of the first 6 months of exposure and at the conclusion of all tests. Figures 113 and 114 illustrate the crack maps for the west end 4A (untreated, post-polymer) and east end 4B (untreated, post-FRP). The crack widths on the west face varied from 0.003 to 0.009 inches. The northwest face crack width was 0.002 inches and the southwest face crack width was 0.005 inches. The crack widths on the east face ranged between 0.002 and 0.003 inches. The northeast crack width was 0.003 inches. No cracks were observed on the southeast face after 6 months of exposure.

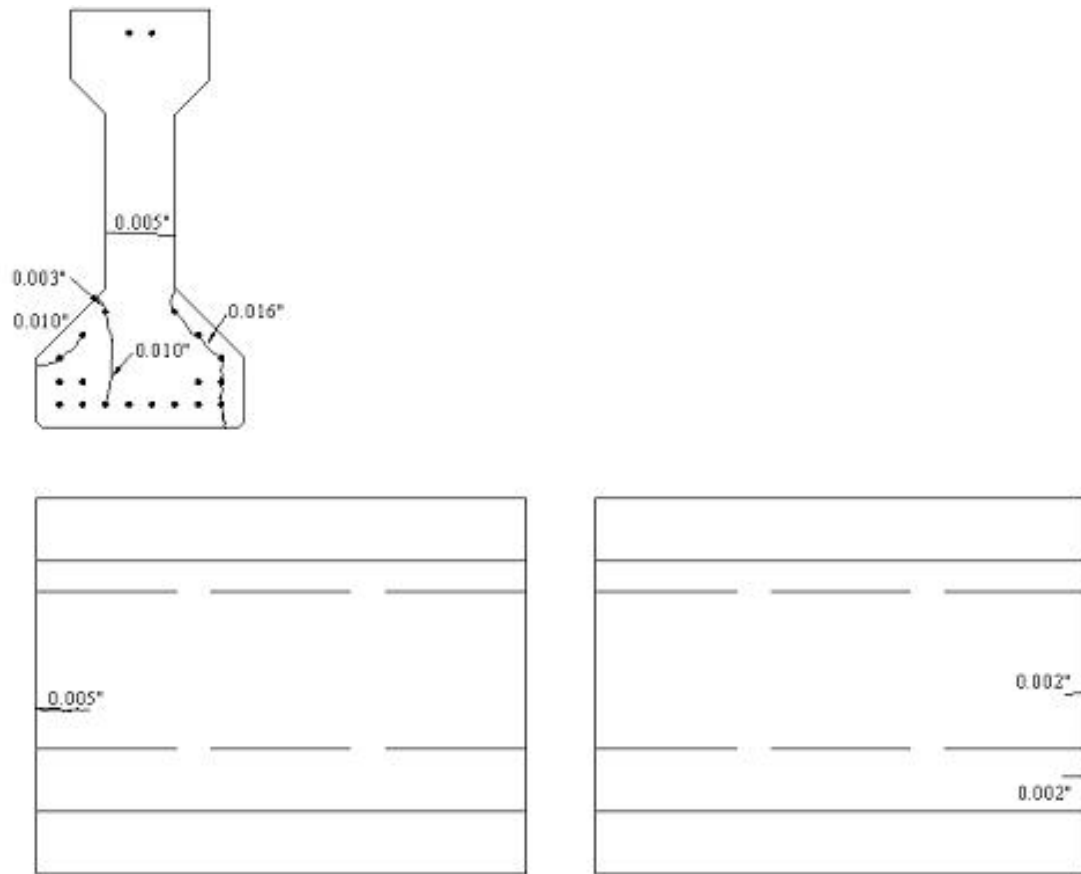
Figure 115. Beam End 4A: West (top), Southwest (left), Northwest (right) (18 months)

Figures 115 and 116 show crack maps after 18 months of exposure for the 4A and 4B beam ends, respectively. Additional cracking developed at the end face of 4A from 6 months to 18 months.

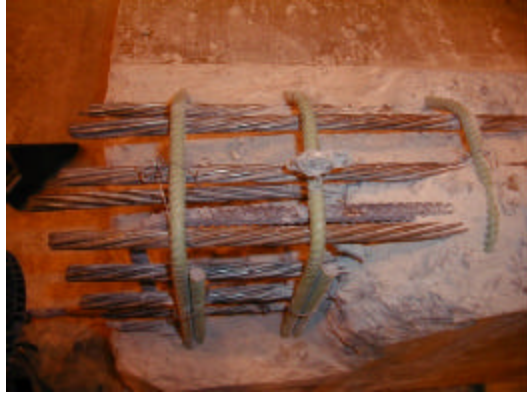
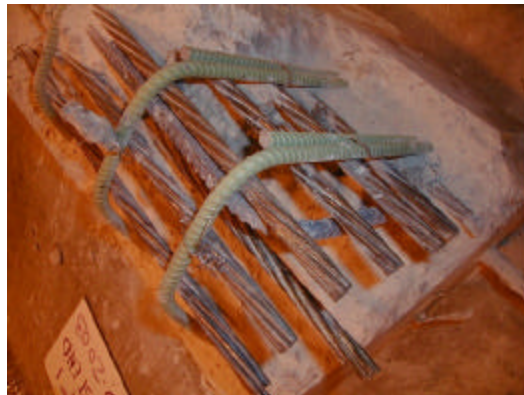
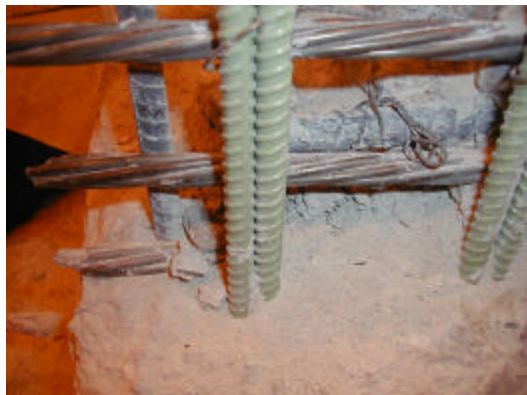
Figures 117 thru 128 show the condition of strands after dissection for all beam-ends. A numerical rating of bottom strand samples based on the PCI reference [55] are given in Table 33. Among the beam-ends treated from the first day, the FRP wrap and polymer resin coating were rated the best. For beam-ends treated after 6 months of exposure, the Silane sealer and polymer resin coating were judged the best with respect to strand corrosion.

Figure 117. Beam End 1A – Treated With Epoxy Coating From Day 1

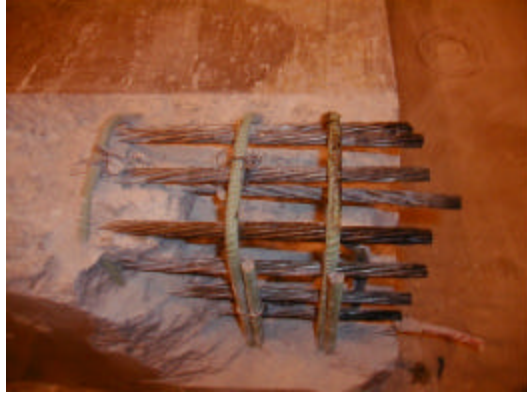
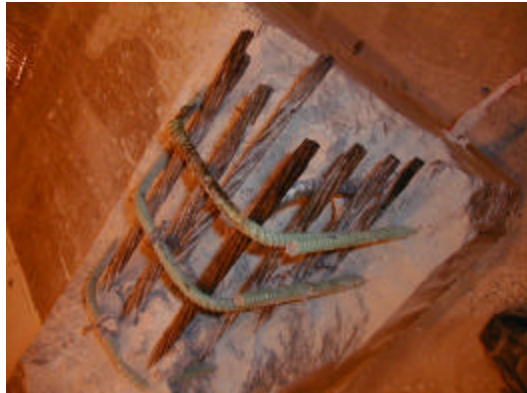
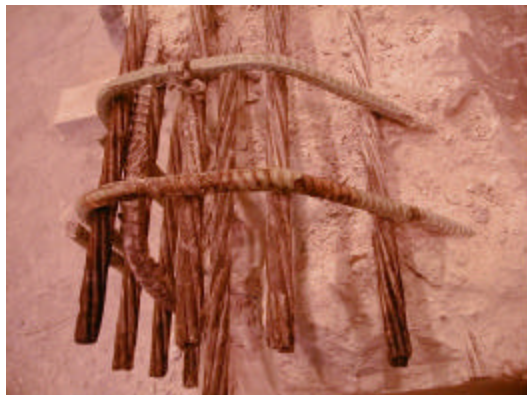
Figure 118. Beam End 1B – Treated With Epoxy Coating After 6 Months of Exposure

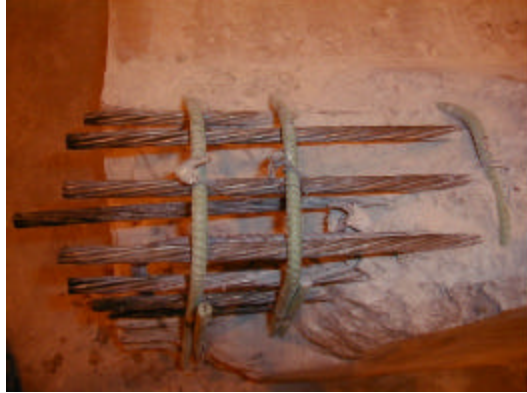
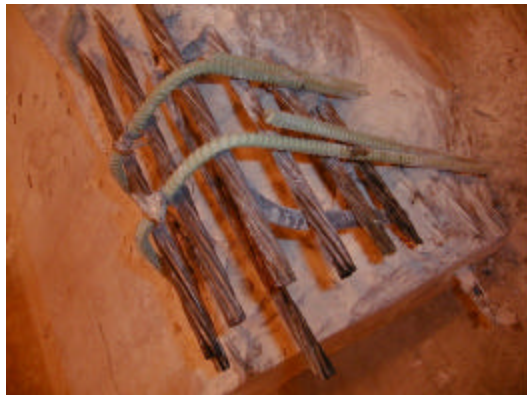
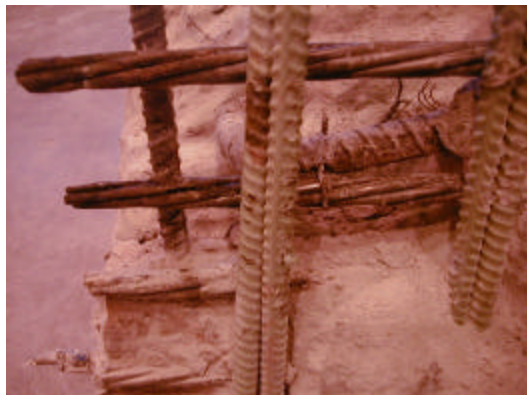
Figure 119. Beam End 2A – Not Treated At All

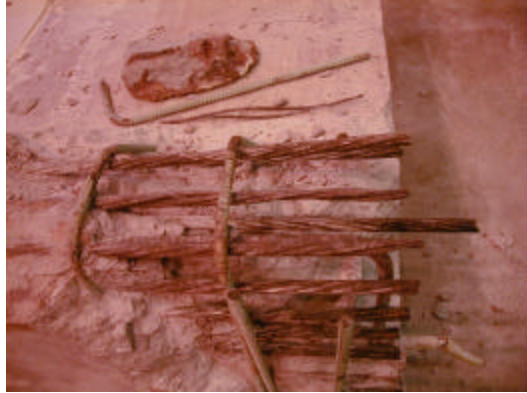
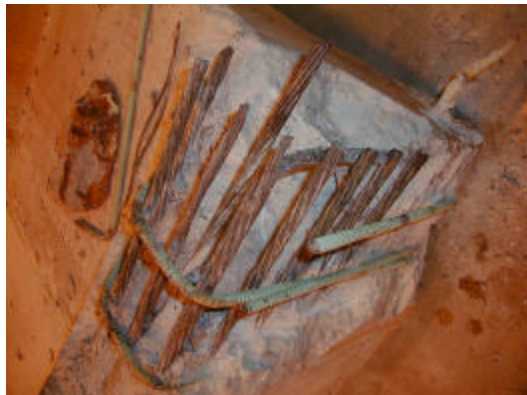
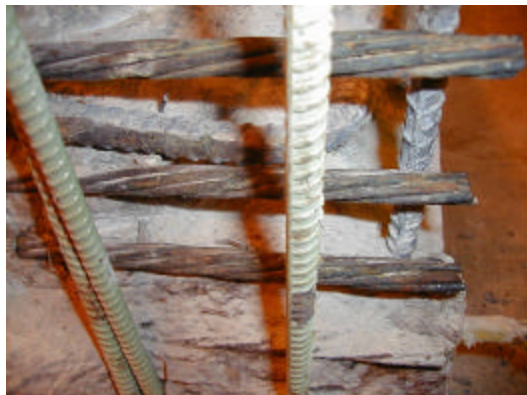
Figure 120. Beam End 2B – Patch Repair After 6 Months of Exposure

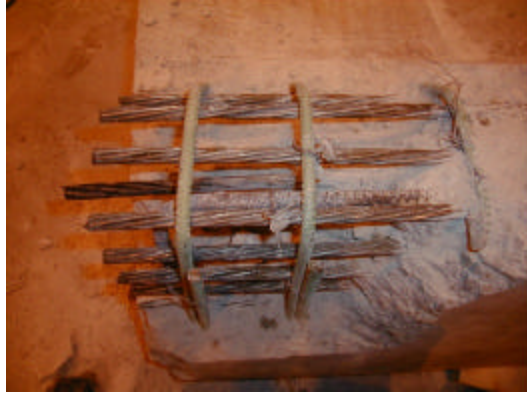
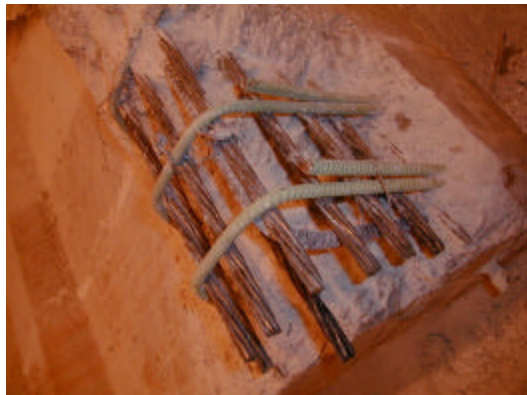
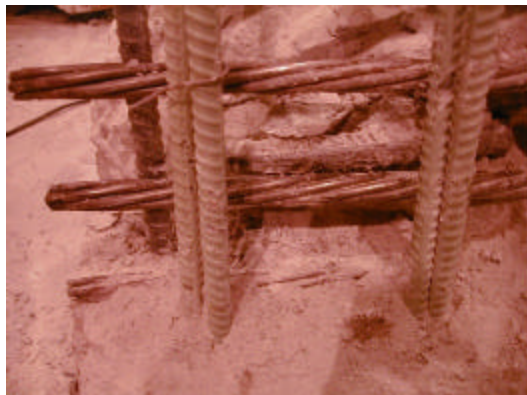
Figure 121. Beam End 3A – Treated With Silane Sealer From Day 1

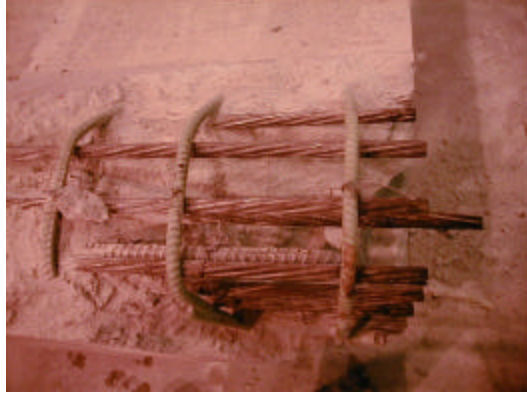
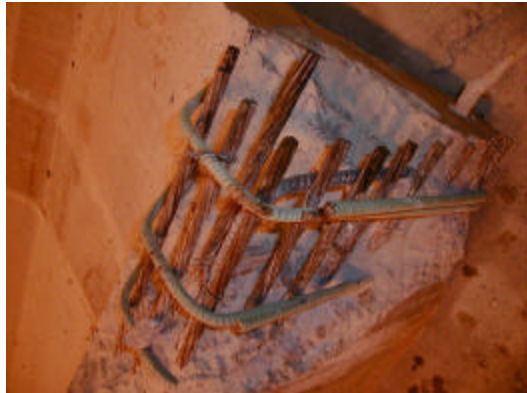
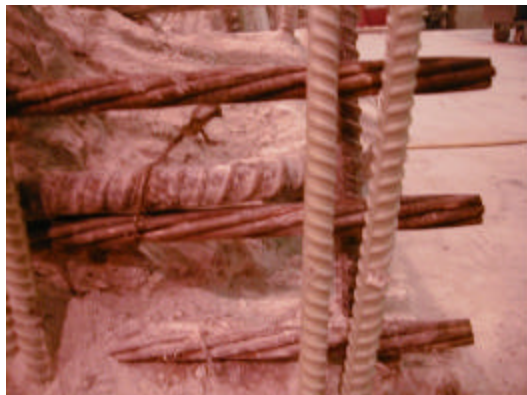
Figure 122. Beam End 3B – Treated With Silane Sealer After 6 Months of Exposure

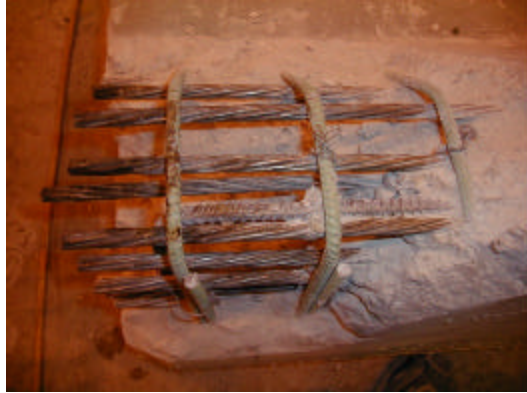
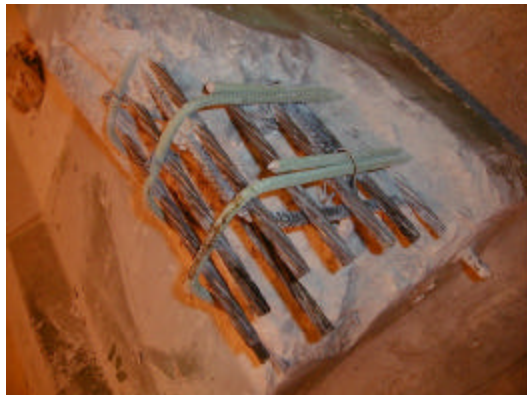
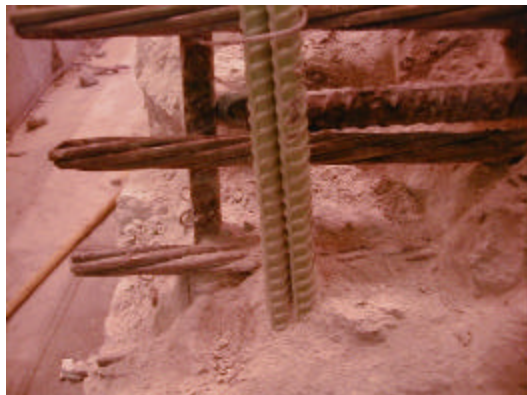
Figure 123. Beam End 4A – Treated With Polymer Resin Coating After 6 Months of Exposure

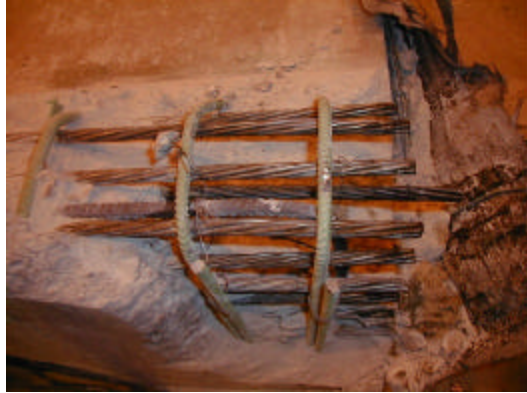
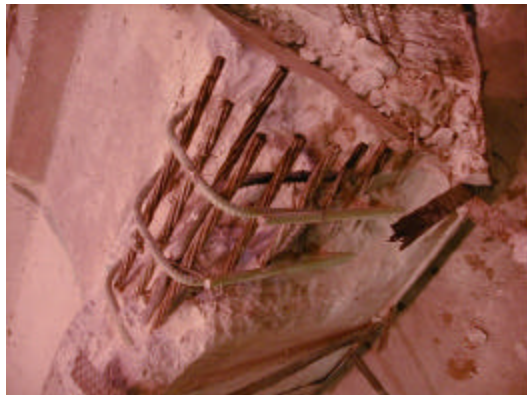
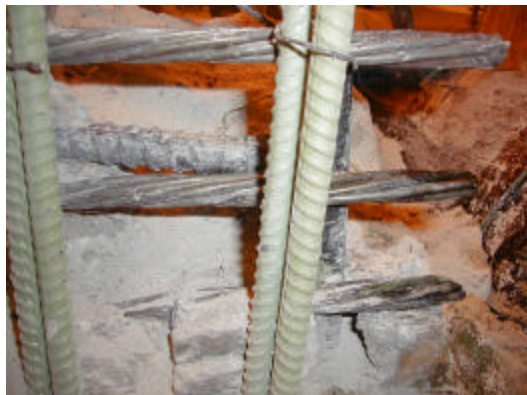
Figure 124. Beam End 4B – Treated With FRP Wrap After 6 Months of Exposure

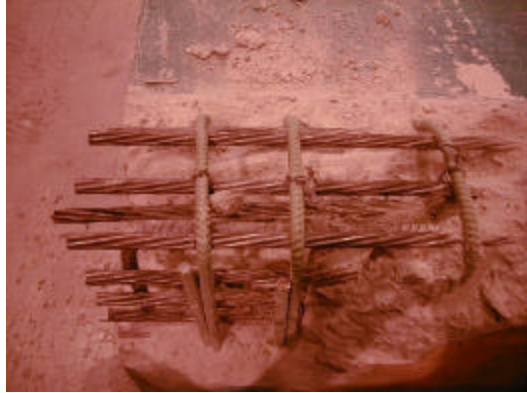
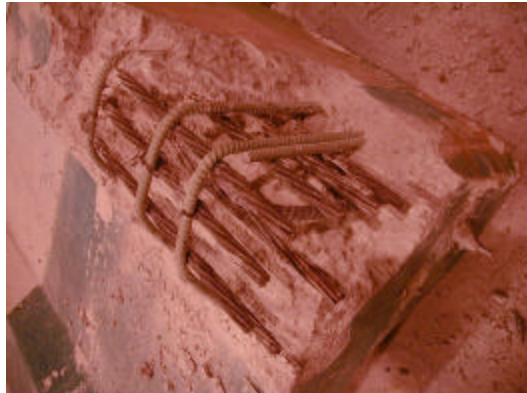
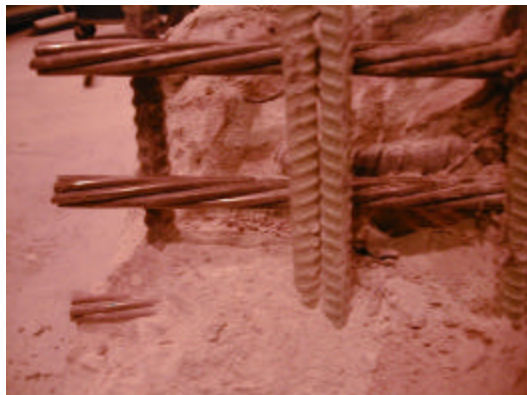
Figure 125. Beam End 5A – Treated With Polymer Resin Coating From Day 1

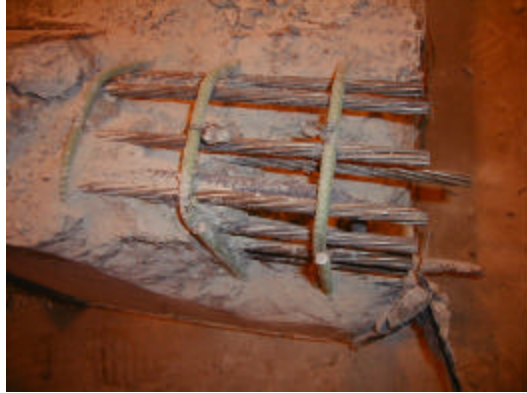
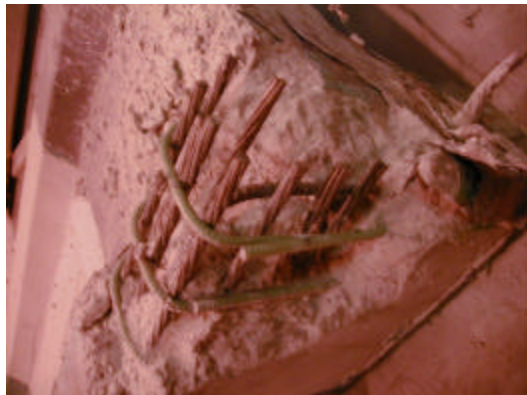
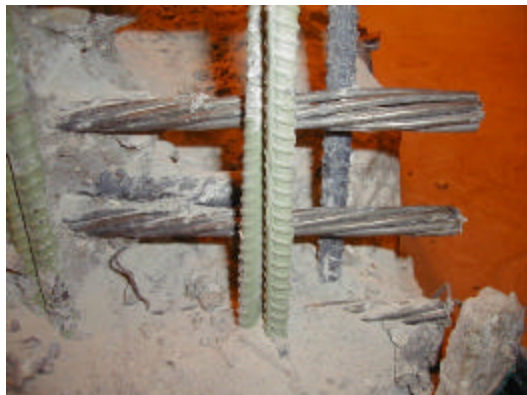
Figure 126. Beam End 5B – Treated With FRP Wrap From Day 1

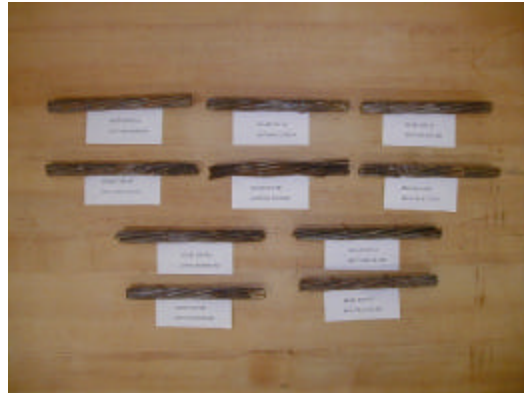
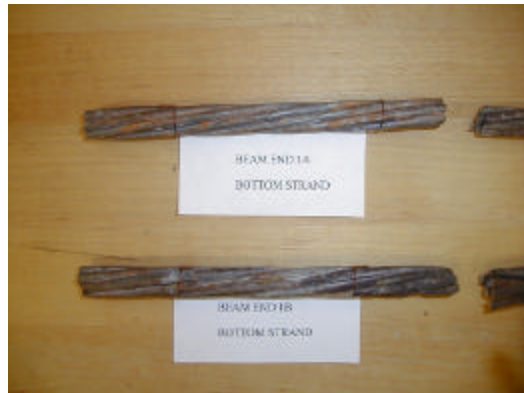
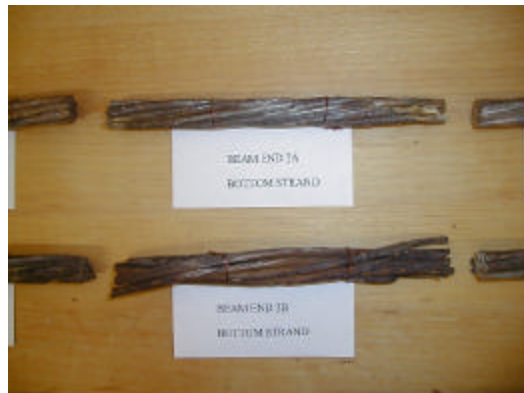
Figure 127. Comparison of Strands with Respect to Corrosion

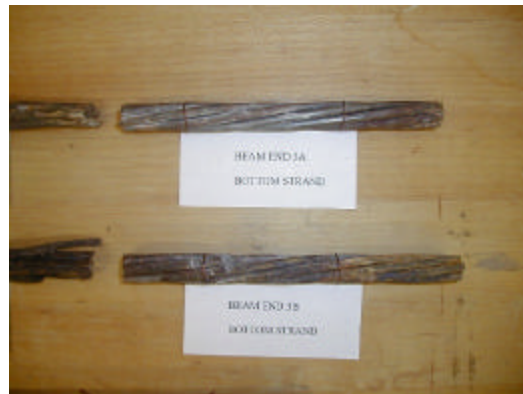
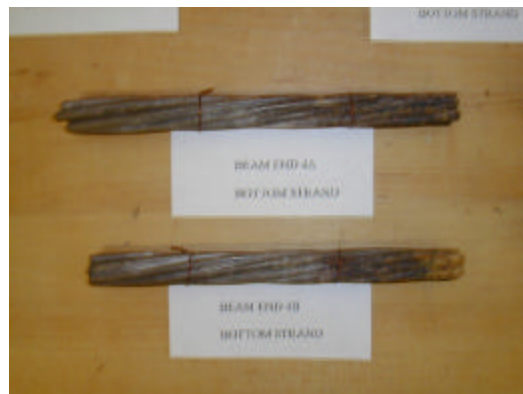
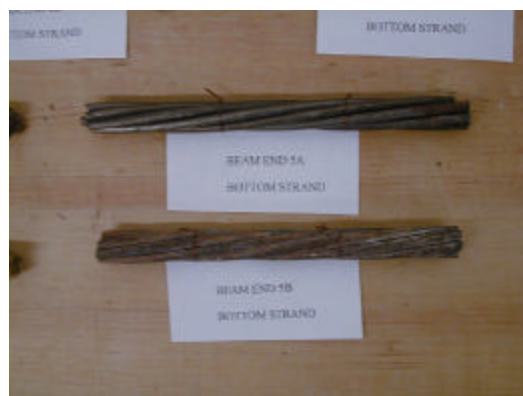
Figure 128. Comparison of Strands with Respect to Corrosion
